Little Faringdon Field Trip Report

A village scale sewerage and water supply system featuring
heritage withy wetland sewage treatment

Internship Study

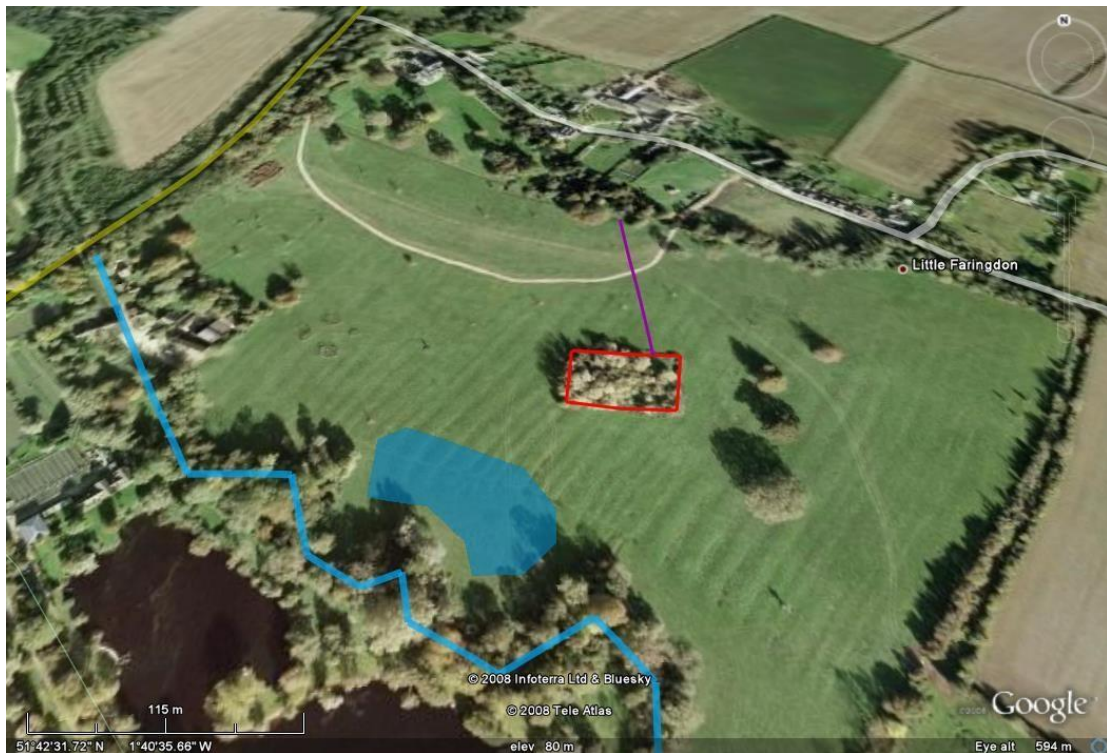
The withy bed

The withy bed measures approximately 45 m by 65 m, with the inflow pipe entering on longer side. The area is enclosed by a wooden fence and barbed wire to keep out animals and people. It consists of a series of broadly parallel trenches and ridges, 6 ft wide and up to 2 ft deep. This is a narrower pattern than in the surrounding fields, which appear to exhibit the remains of regulated flood meadow. The willow species of tree are grown along the ridge crests at regular intervals. The withy bed has remained largely untouched since its construction 80 years ago. It acts in a similar way to reed bed or constructed wetland treatment systems. The water is allowed to flow into the soil at one end, and the plant species (typically reeds, but in this case willow) promote growth of bacteria on the roots. The denitrification and nitrification of pollutants and absorption of chemicals allows for a high quality of water cleansing for outflow into water courses. For effective removal of pollutants the withy bed must be constructed correctly, with careful thought to the species, soil type, hydrology and positioning of the system. The ridges and trenches and a gentle 1:200 downhill gradient aid the movement of water through the system, cleaned by bacteria in the plant roots and soil, before it is discharged across the south edge and allowed to infiltrate or run off to the water course.

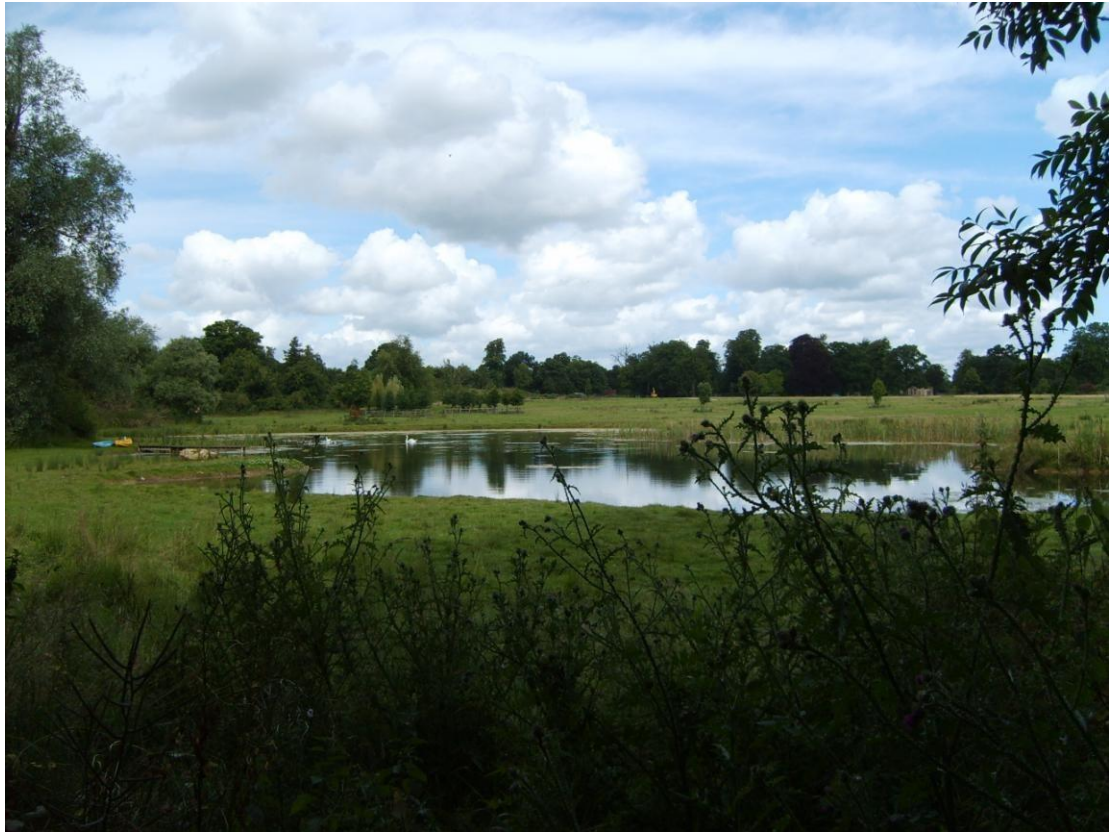
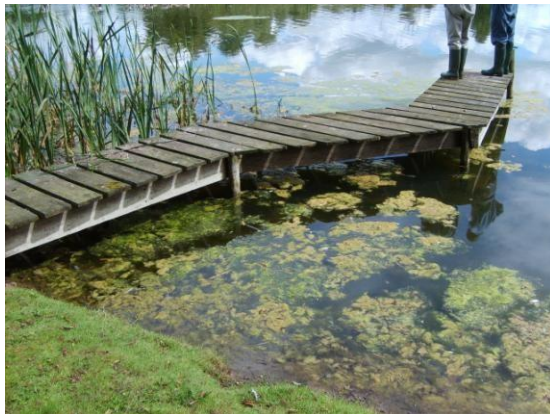
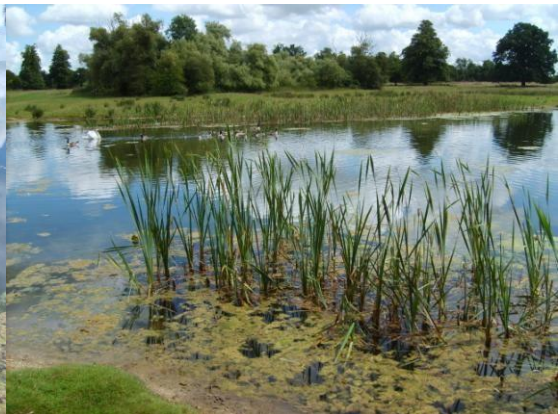
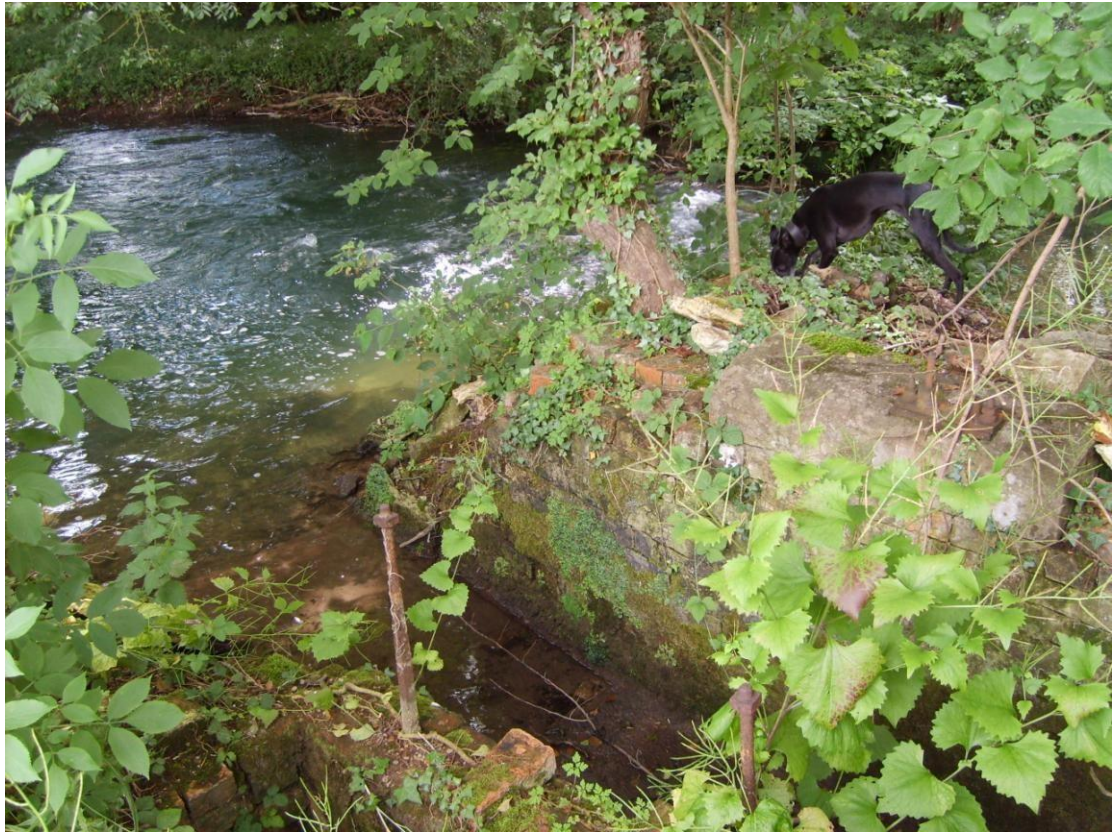
The landowner constructed a pond at the bottom of his field between the withy bed and River Leach. This an unlined pond, dug out of the shallow gravel beds beneath. Here, the water table is at the surface and provides sufficient depth all year round. The pond serves no practical function, as the land is not used intensively; it is aesthetic. It was constructed about three years ago, and few plants or fish live in the pond. It has a few reeds in clusters around the perimeter, and algal blooms on the surface. There is a build up of fine sediment on the bottom of the pond, and there is believed to be a nutrient enrichment, likely caused by the withy bed just uphill releasing treated effluent. The withy bed has for some time needed maintenance and it is likely to be the major source of pollution in the pond.

The landowner would like to reinstate a small underflow water wheel at the weir on the River Leach, at the bend in the water course at the south-east corner of the pond. This will be ornamental, but could potentially be used to pump water into the pond to flush it through and dilute any pollutants. The water wheel is a refurbished 150 year old metal framework with new paddles. The sluices at the weir no longer function, and require refurbishment. It would also require Environment Agency liaison due to

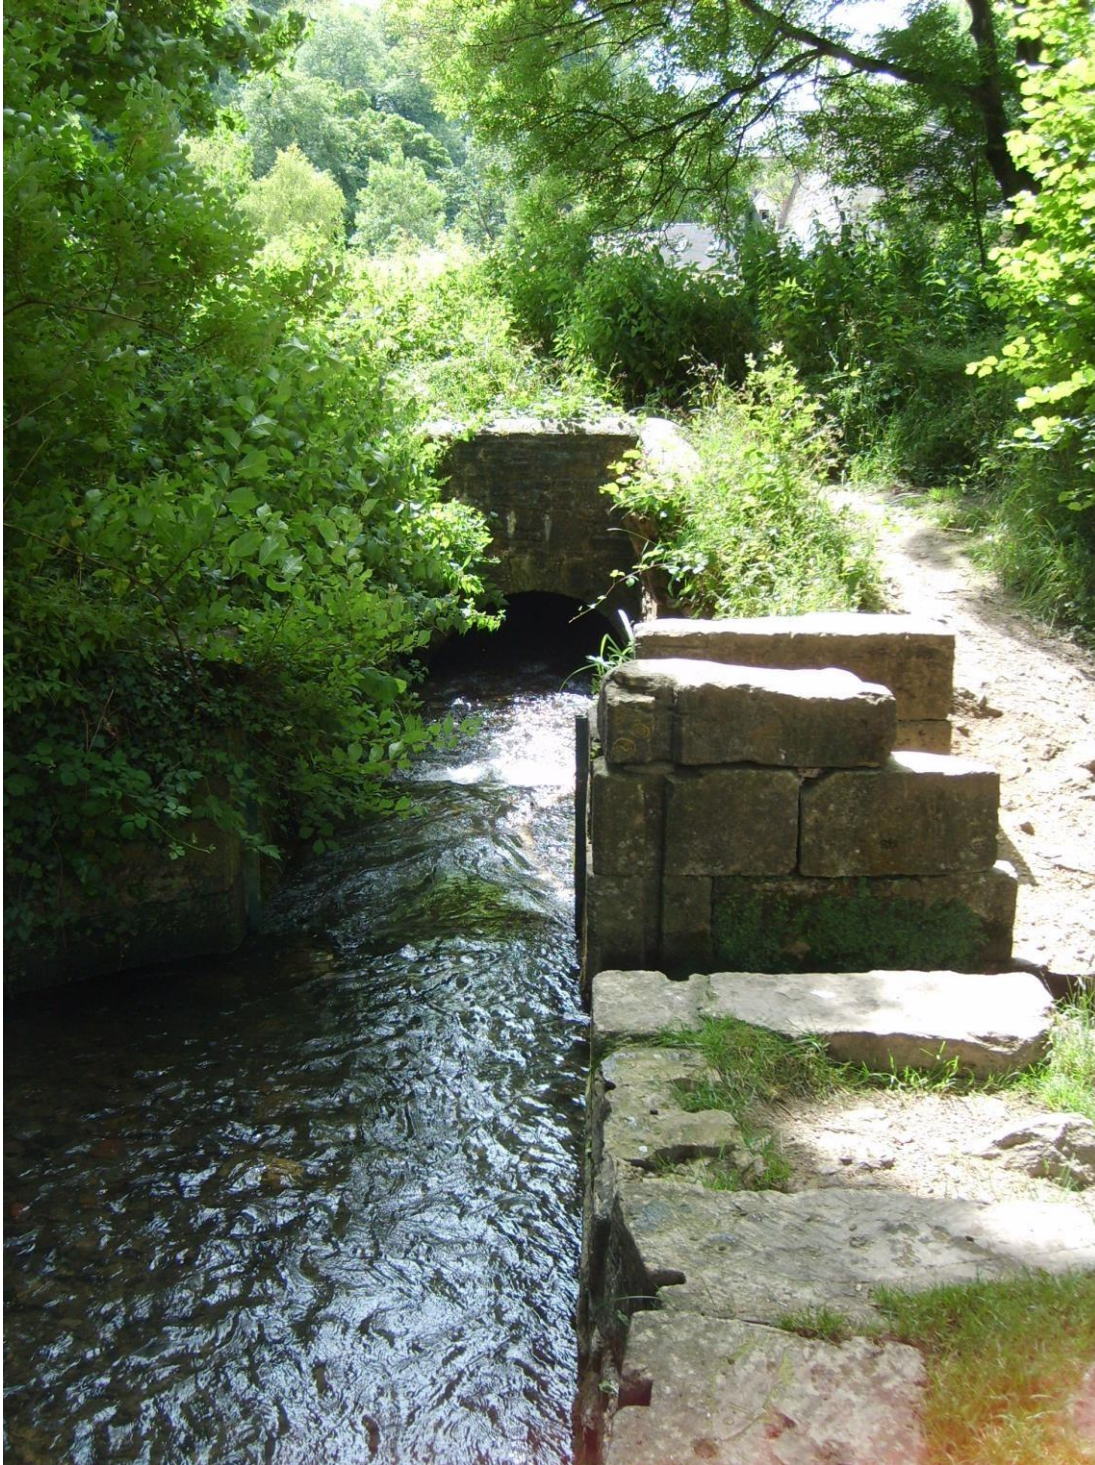
Old sluices remain but are no longer operated

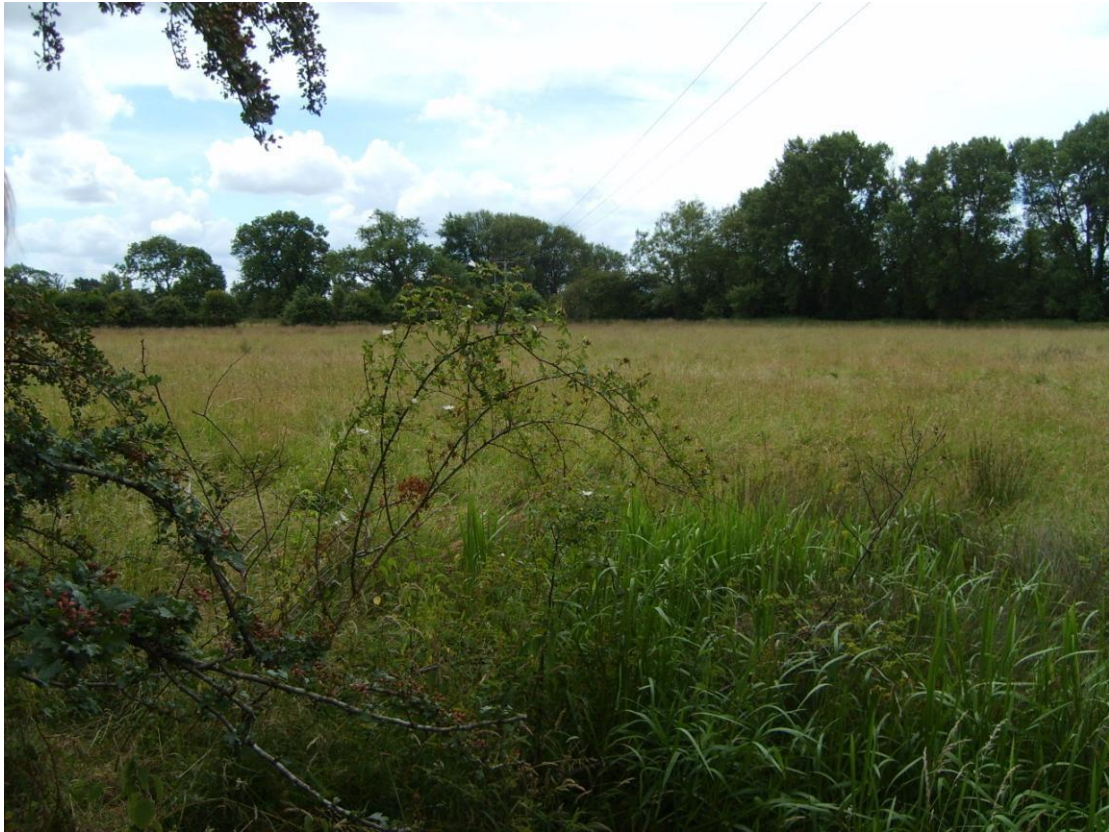
The final feature at this site is an area at the bottom of the last field downstream belonging to the landowner. This land has been allowed to flood and form wetland. The maximum estimated area is 10 acres, and average depth of 18 inches. Approximate maximum storage is therefore 16000 m². This was requested by Defra for ecological habitat restoration, and the landowner was offered a one-off token payment of £150 for constricting some flow of the River Leach to inundate the end of the field. The landowner was happy to do this to encourage snipe for game shooting, and had little use for the land otherwise. It is about 3 years old, and the inundation has promoted growth of grass in the surrounding field.
